Intel[®] Mobile Celeron[™] Processor Specification Update

Release Date: October 1999

Order Number: 244444-008

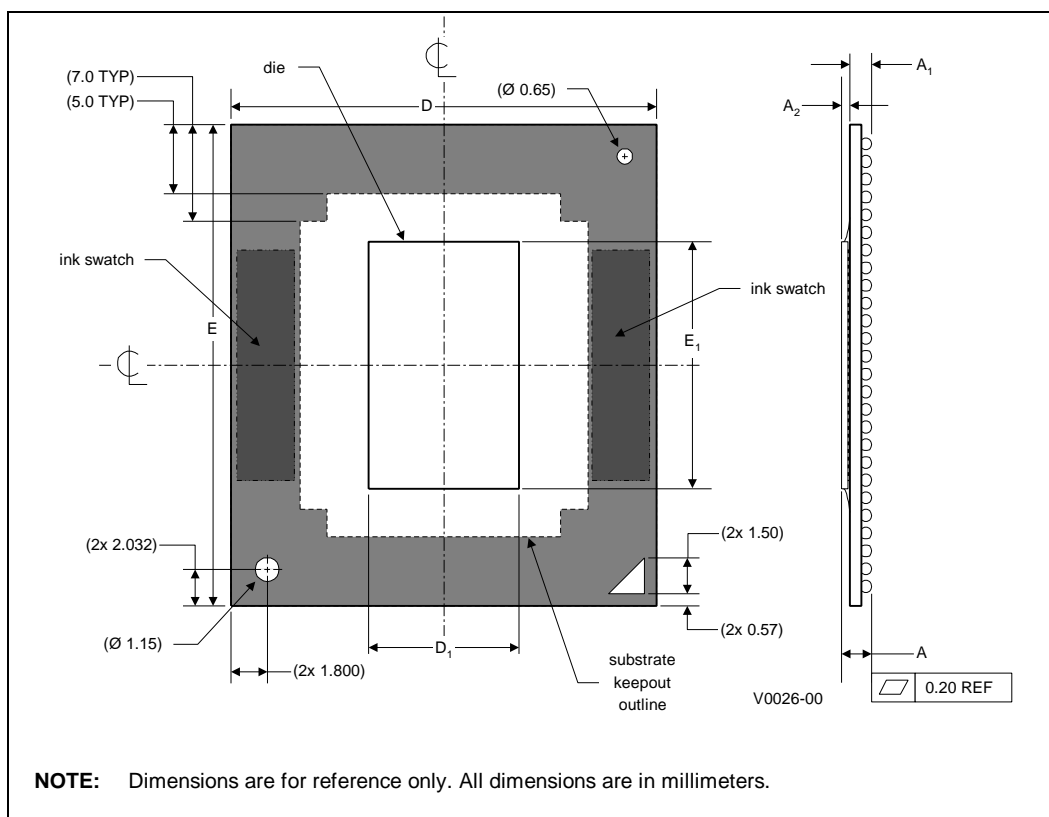
Figure 5.3. Surface-Mount BGA1 Package—Top and Side View

The following table and figures show the updated mechanical specifications for the BGA1 package, listed as Table 5.2, Figure 5.3 and 5.4, respectively, in the *Intel® Mobile Celeron™ Processor in BGA Package at 333 MHz, 300 MHz and 266 MHz* datasheet.
